# B6399 flood damage assessment

Detailed inspections have taken place since Sunday 16 February to understand the full extent of the damage caused and develop proposals for the necessary repairs. There are seven badly damaged areas to the road.

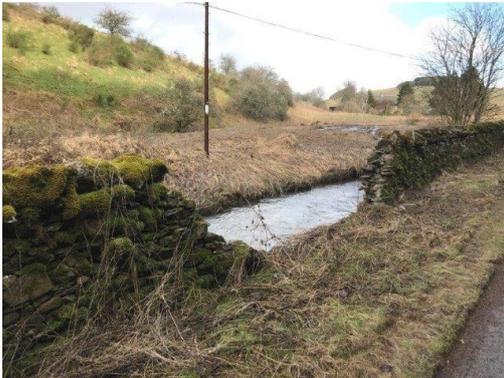
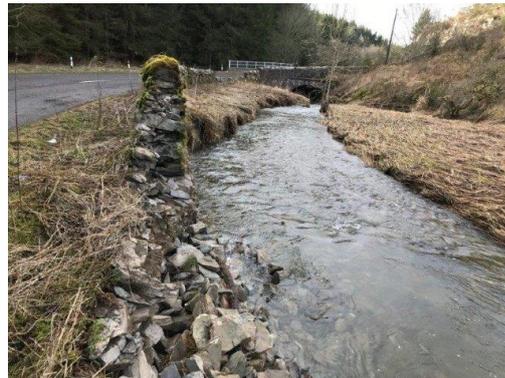
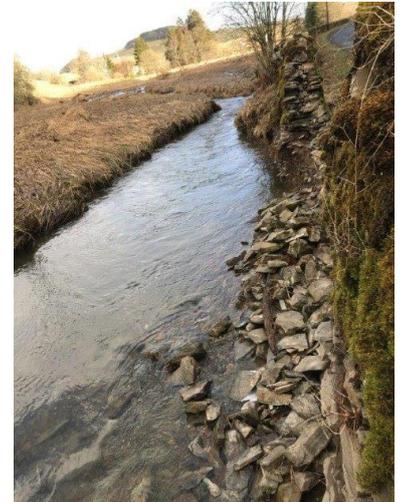
## **Cogsmill:**

*A section of wall approximately 5m long has been undercut, resulting in the collapse of the wall. The wall requires rebuilding with additional protection at the base to prevent further erosion.*

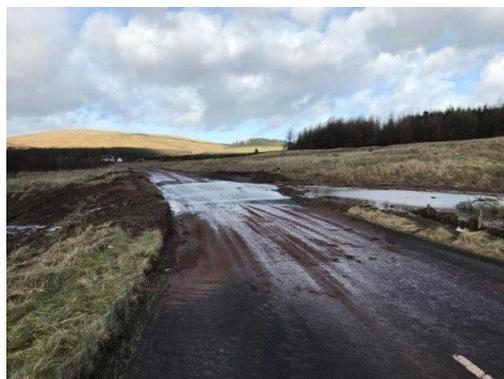
## **East Broomy Cleuch:**

*The upstream side of the culvert is blocked, resulting in a dam-like effect which has resulted in water running over the road. The blockage needs to be removed and the surface assessed for any damage and repairs undertaken as required.*

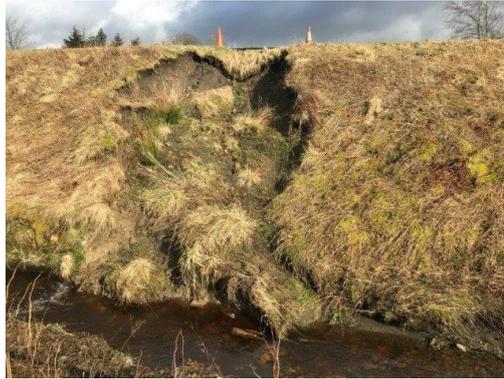
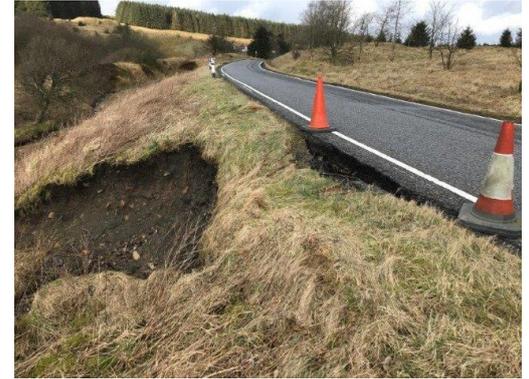
### **Windshielknowe:**

*A small landslip has occurred, around 5m in length, resulting in erosion adjacent to the road. Works are required to restore the area and prevent future erosion at the base.*

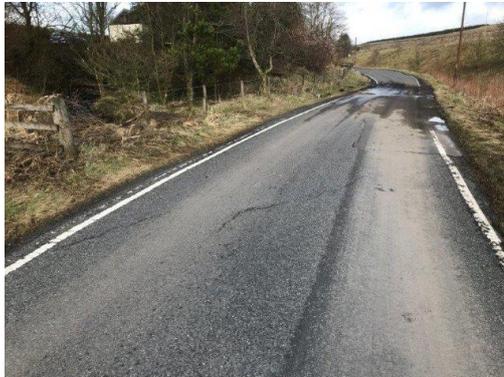
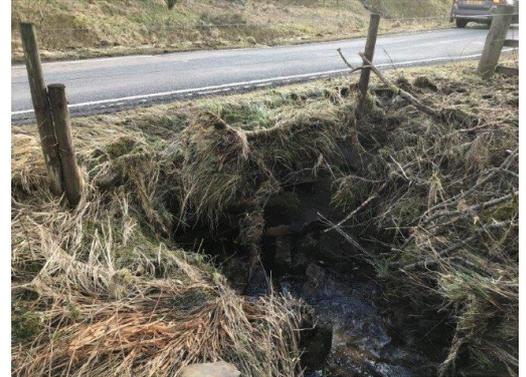
### **Signalman's Cottage:**

*A pipe under the road has blocked, causing water to flow over the road. Cracking of the road surface has occurred. Repairs are required to an areas scoured by the water and consideration given to putting a large pipe in place beneath the road surface.*

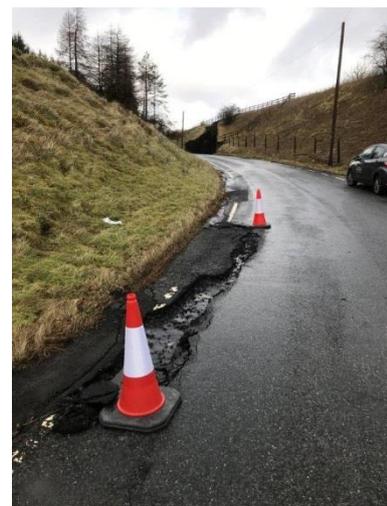
### **Whitrope Culvert:**

*There are numerous areas at this location where the road edge and some areas of road surface have deteriorated due to the water flow.*

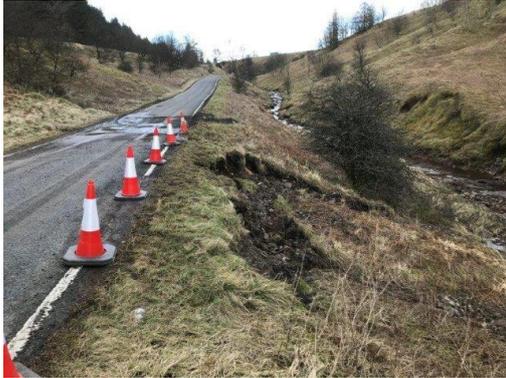
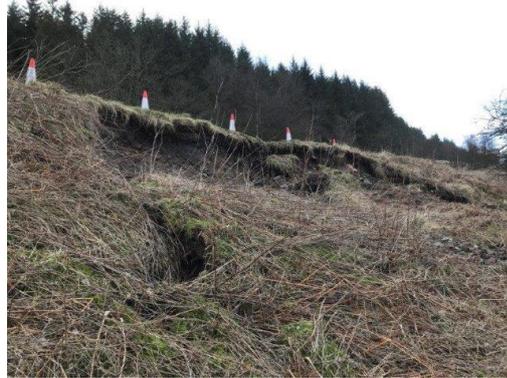
## Larriston Knowe:

*The base of the embankment has been washed out, resulting in a landslip approximately 10m in length. This has resulted in erosion adjacent to the road surface. The slip area requires reinstatement and the base of the embankment strengthened to prevent future erosion.*

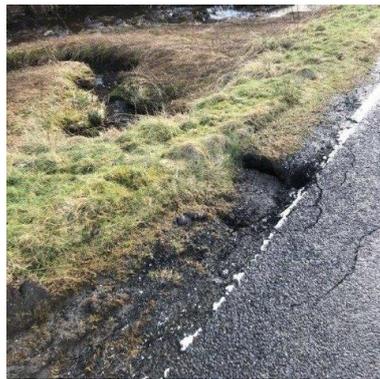
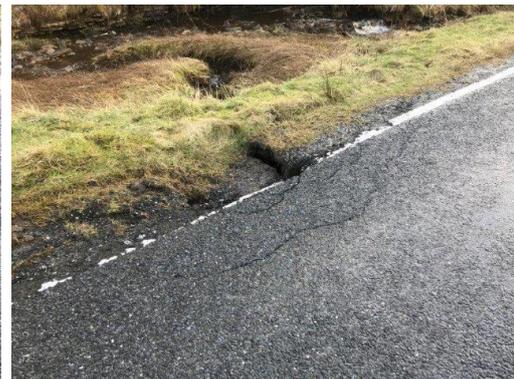
## Whitrope Edge (north):

*The piped road crossing has been damaged at the downstream outlet, resulting in a sinkhole in the road. The damaged area requires excavation and further assessment of the pipe.*

*An area of embankment slip nearby has already been repaired.*

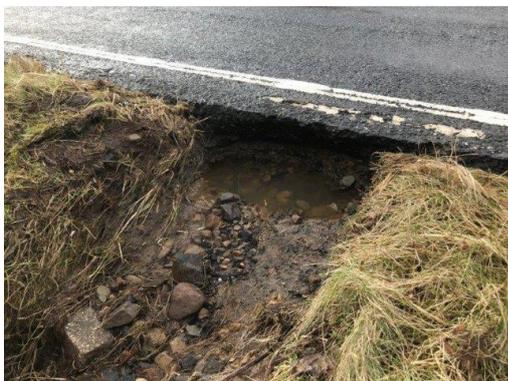
## North of Sundhope:

*The road edge has been washed, leaving the road edge vulnerable. Repairs are required to strengthen the embankment and reinstate the verge.*

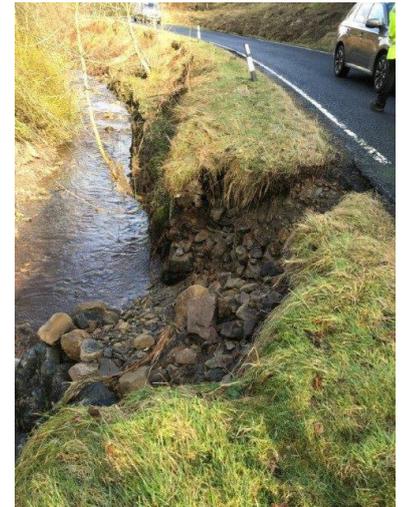
## North of Whitropefoot:

*The road edge has been washed out and the embankment scoured out. Repairs are required to the embankment and verge, with strengthening work and additional protection to prevent further scouring.*

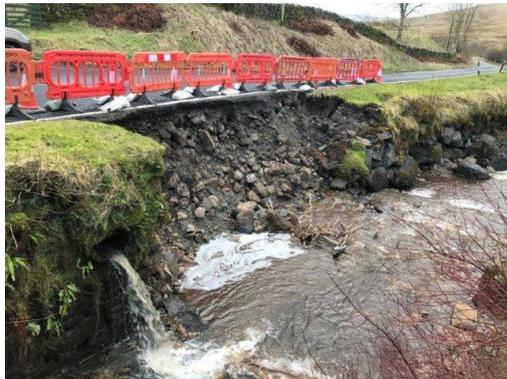
## Whitropefoot:

*There is a significant area of embankment erosion, or possibly a collapsed section of roadside wall. The embankment/wall needs to be reinstated and built up to the full height of the embankment.*

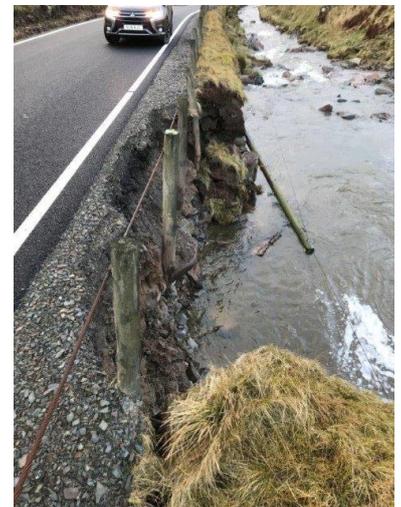
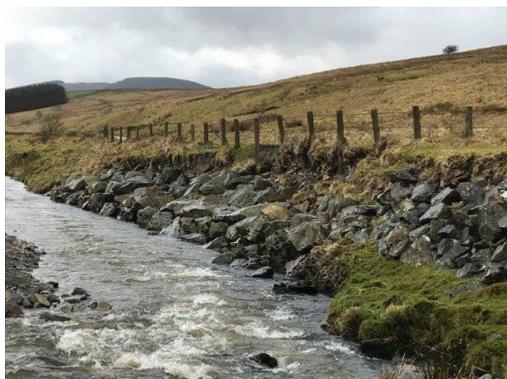
## Dawston Burn:

*There are three significant areas of embankment erosion with around 1.4km of each other. The embankment/wall should be reinstated up to the full height.*
