Leahaugh, Scottish Borders

Pre-afforestation Historic Environment
Assessment

Project ID: 095

Data Structure Report
on behalf of
Buccleuch Estate

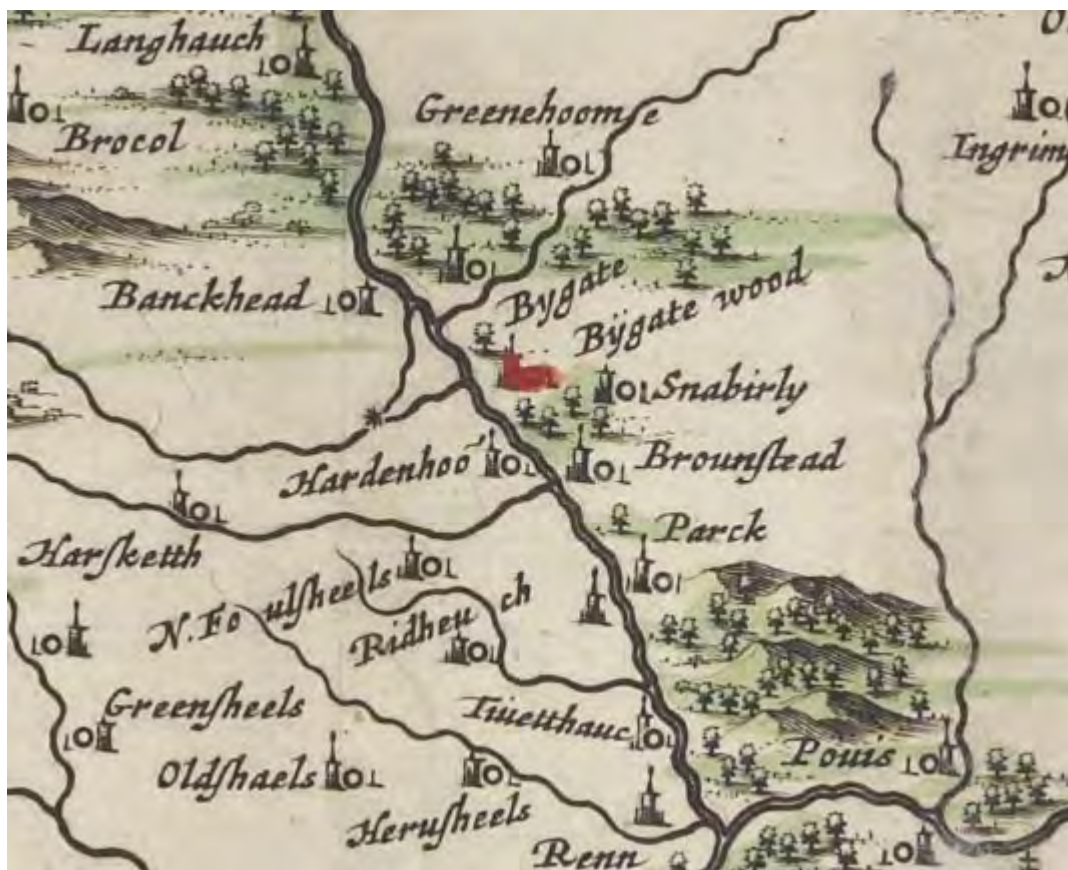
Illustration 2: Extract of Blaeu's Atlas of Scotland (1654), courtesy of the National Library of Scotland

Although no detail is present Blaeu's Atlas of Scotland (1654) marks the settlements of 'Greenhoomse, Bygate and Snabirly' (Illus. 2). These are place names also present on later maps of the assessment area (see below). Moll's map of 1745 also depicts 'Bygate'.

Matthew Stobie's map of 1770 (Illus. 3) and John Thomson's map of 1832 show the settlements of 'Leehaugh/Leyhaugh, Backgate/Byegate, Snaberly and Greenholm/Green Holm', although Green Holm appears to the south of Byegate and Snaberly rather than to the north as shown on Blaeu's map (Illus. 2).

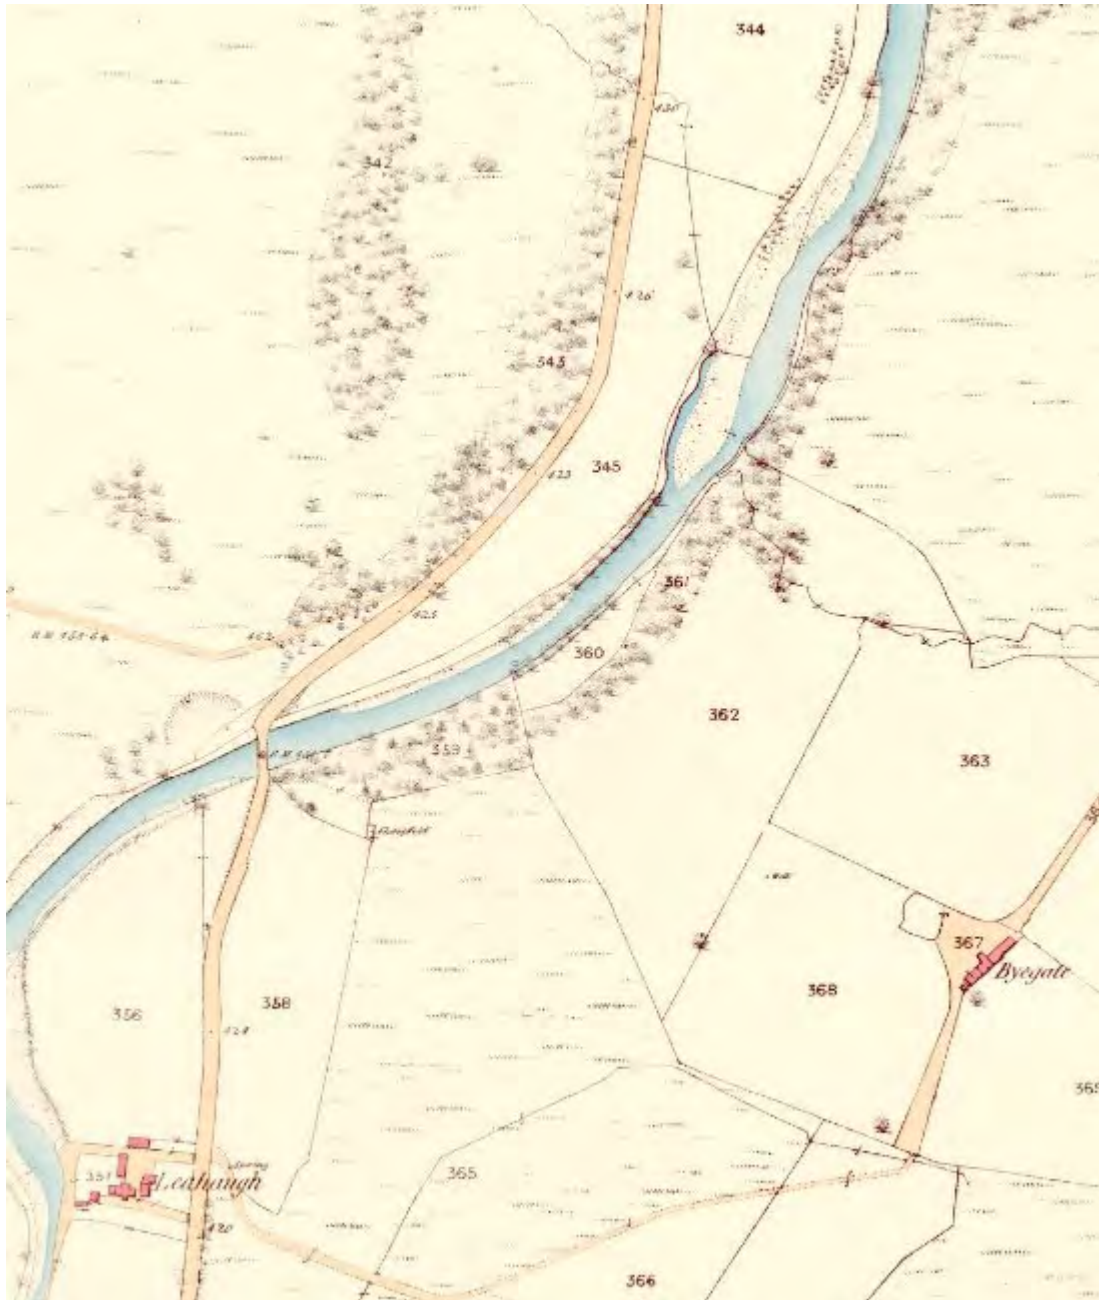
Illustration 4: Extract of the OS 25 inch to the mile map surveyed 1857-8, showing Leahaugh & Byegate, courtesy of the National Library of Scotland

The OS 25 inch to the mile series, surveyed 1857-8 and published in 1859 records three settlements within the assessment area including Bygate (Illus. 4, see **Site 34** below), Snaberlee (Illus. 5, see **Site 24** below) and North Greenholm (Illus. 5, see **Site 25** below).

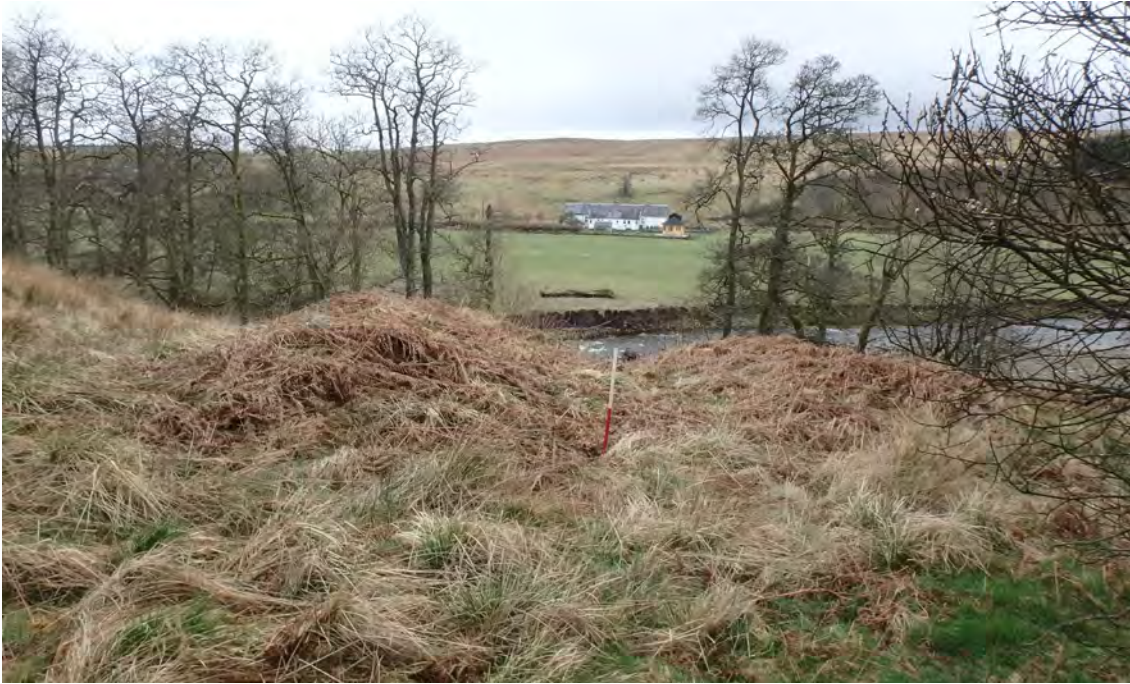
Illustration 7: Possible earthwork ramparts of Site 16.

No confirmed evidence of prehistoric activity has been recorded within the assessment area although it is possible that the earthwork defined by two large banks/ramparts and ditches (**Site 16**, Illus. 7) has prehistoric origins. The earthworks enclose a relatively small area indicating parts may have been severely eroded by the adjacent Hermitage Water.

It is also possible that the earthwork (**Site 16**, Illus. 7) either originated or was reused in the medieval period.

No sites with a value at a national level were noted within the assessment area while only one site with a value at a regional level was recorded. This was the possible prehistoric or medieval earthwork defined by two large banks/ramparts and ditches (**Site 16**, Illus. 7), although this value may be lessened if the majority of the site has been eroded away by the river.

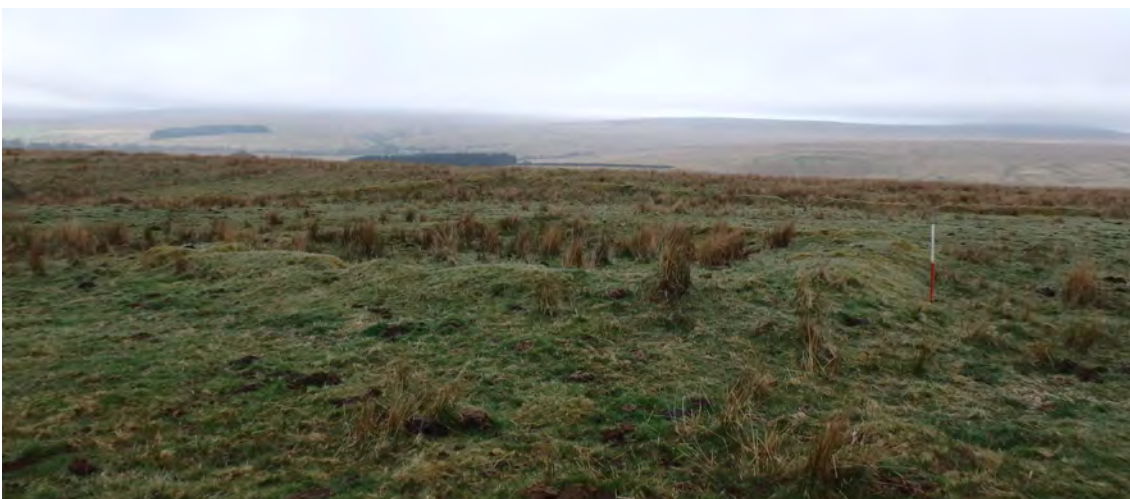
Illustration 8: Small enclosure defined by earth banks forming part of Site 1

For example, a complex of earthen bank field systems was located at the northern end of the survey area (**Site 1**). The banks were relatively well defined being up to 3m wide and 0.75m high. A square enclosure (Illus. 8) lay in the centre of the complex while faint traces of cultivation remains were visible on the 0.5m resolution lidar data on the northern and western sides of the field system. No associated settlement remains were visible.

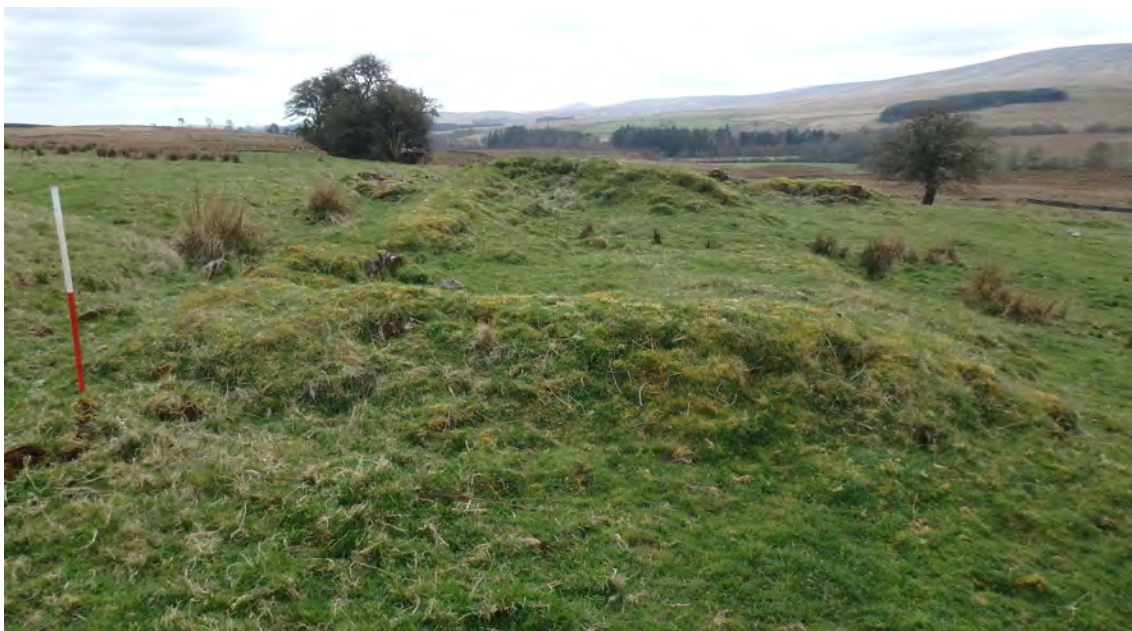
Illustration 9: Remains of a building at Bygate (Site 34).

Remains of three former farming settlements were recorded within the assessment area, all of which are noted on the early OS mapping of the area. The most northerly was Bygate (**Site 34**) which comprised the collapsed walls of a long rectangular building some 25m in length (Illus. 9), a small rectangular enclosure measuring 25m by 20m defined by turf covered banks up to 1.5m wide and 0.5m high and further linear turf banks extending to the north, west and south that relate to former field systems around the farmstead building. Faint linear cultivation rigs were visible on the 0.5m resolution lidar data within the improved fields to the north-west and south-west of the building but were less visible on the ground. This farmstead is annotated 'Bygate' on the OS 25 inch to the mile map (Roxburghshire, XLII.11 (Castleton) Surveyed in 1857-58, Published in 1859, Illus. 4) and likely also relates to 'Bygate' on Bleau's map of 1654 (Illus. 2), 'Baggott' shown on Roy's map of the mid 1800s and 'Backgate' shown on Stobie's map of 1770 (Illus. 3).

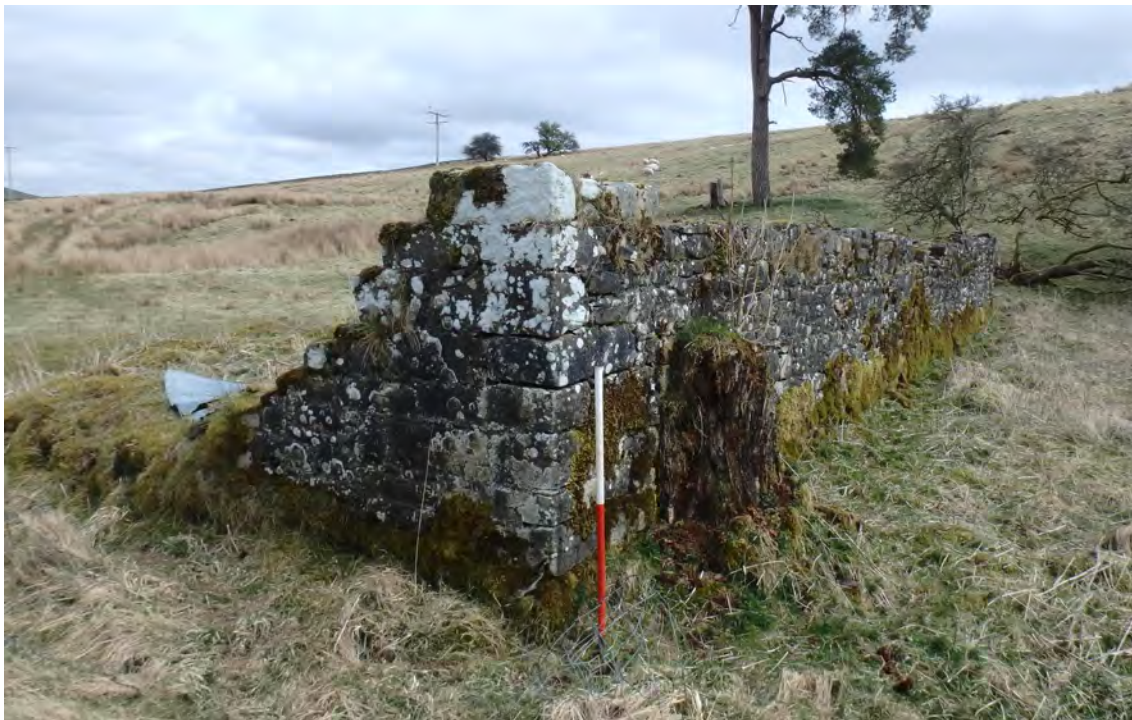
Illustration 10: The remains of a building at North Greenholm (Site 25).

Some 600m south of Snaberlee (**Site 24**) lay a ruined building related to to former settlement annotated 'North Greenholm' (**Site 25**) on the OS 25 inch to the mile map (Roxburghshire, XLII.15 (Castleton) Surveyed in 1857-58, Published in 1859, Illus 5). Only the southernmost of the two buildings shown on the early OS maps was visible (Illus. 10) while a small enclosure defined by a hedge lay to the south. This farmstead also likely relates to the unnamed buildings south-west of Snaberlee on Roy's map of the mid 1800s and 'Greenholm' on Stobie's map of 1770 (Illus. 3).

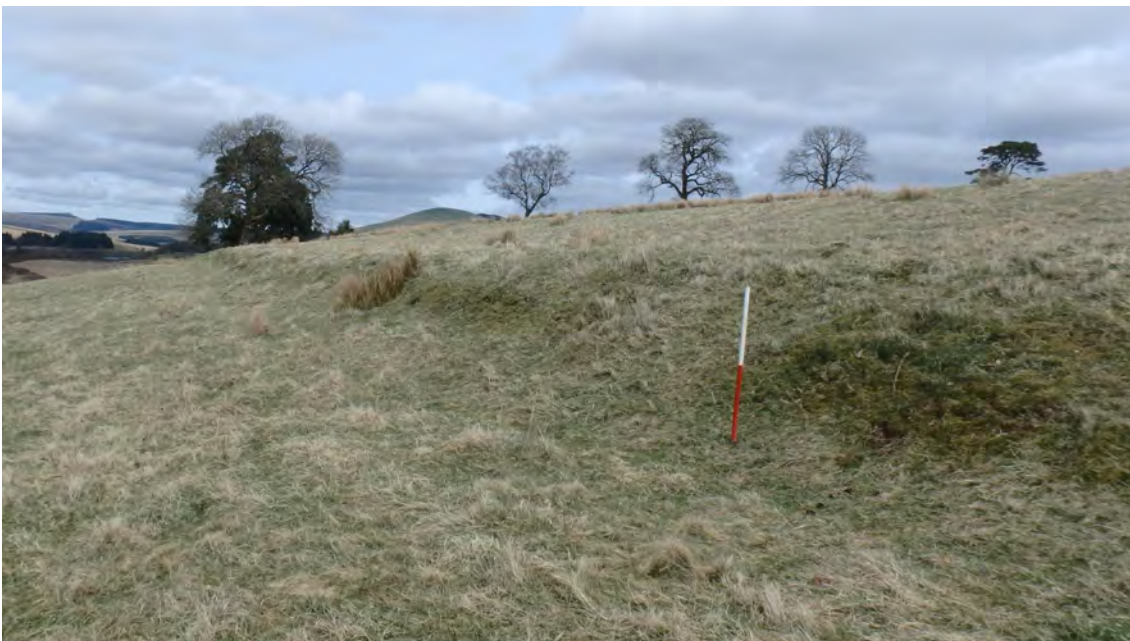
Illustration 12: Scarp forming part of a varied complex of field enclosures (Site 28).

the varied boundary types of the former field system in the southern part of the assessment area (**Site 28**) which were formed from steep scarps (Illus. 12), field banks and banks with associated ditches.

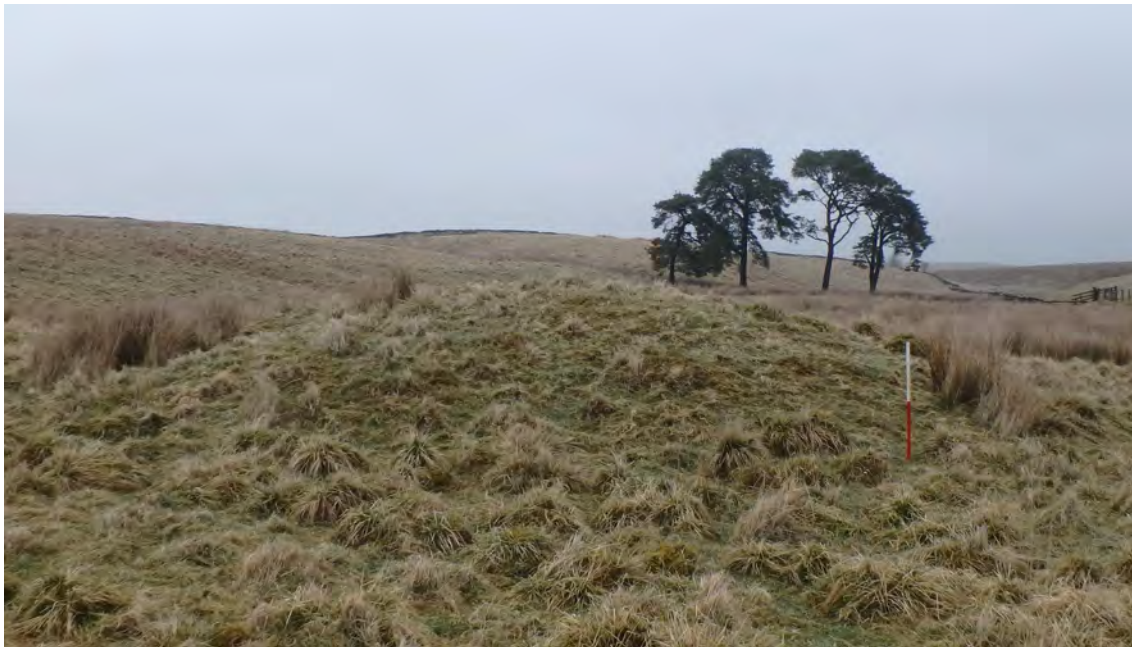
Illustration 13: Mound (Site 8) of unknown origin or date.

Two sites of unknown date were recorded within the assessment area. A distinctive large grass covered mound (**Site 8**, Illus. 13) was noted in the south next to a burn. It existed to 2m in height and 12m in diameter. The feature could be a natural formation, however, no other examples were noted in the assessment area and there is a possibility it is archaeological.
